# Manhole Inspection Summary

Manhole # S11Q\_\_005MH

Insp Date: **4/18/08 9:37 AM**

**Location** Address: **521 S Caton Ave**

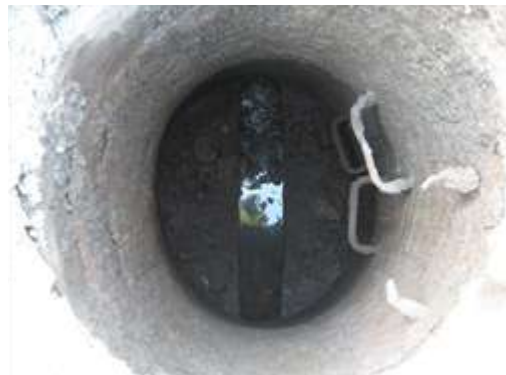
Top View

evidence of chimney infiltration

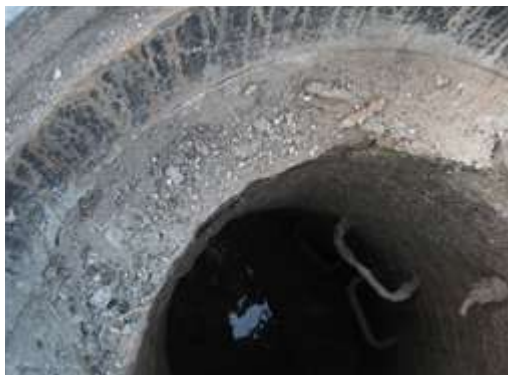
Defect 5

**Frame** Offset: **4** (in.) Condition: ☐ Sound ☐ Cracked ☒ **Leaks**

Frame offset 4"

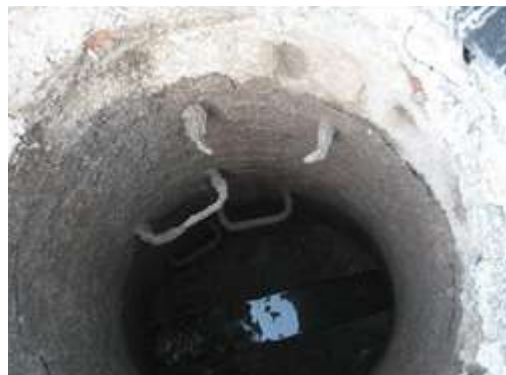
Defect 2

Condition: ☐ Sound ☒ **Cracked** ☐ Root Intrusion ☐ Loose Brick ☐ Deteriorated

**Steps** Count: **3** Missing: **1** ☒ **Corroded**

cracked corbel, Corroded steps/  
infiltration at corbel and barrel

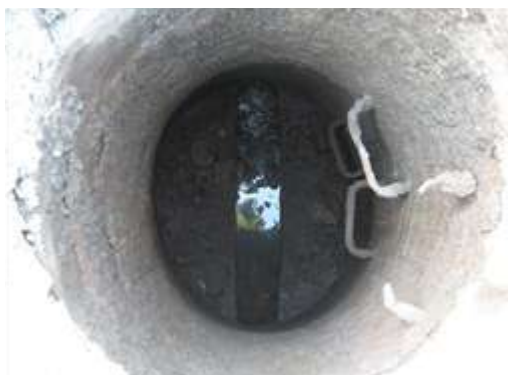
Defect 6

Condition: ☐ Sound ☐ Cracked ☐ Root Intrusion ☒ **Loose Brick** ☐ Deteriorated

evidence of chimney infiltration & loose  
bricks

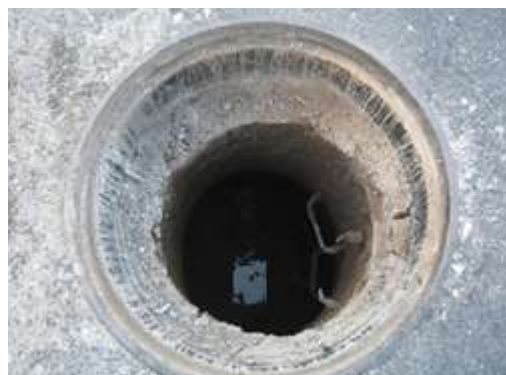
Defect 3

frame leaks, frame offset

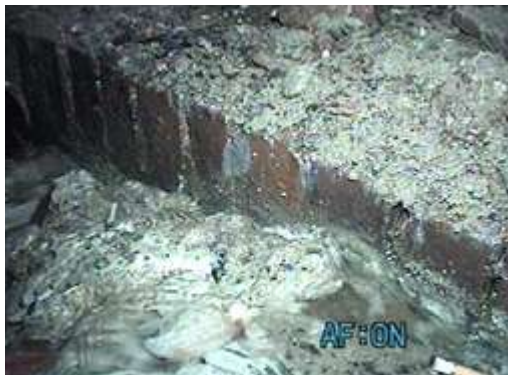
Defect 1

Condition: ☐ Sound ☐ Cracked ☐ Root Intrusion ☐ Deteriorated ☐ Leaks ☒ **Debris**

Heavy debris in channel and on bench

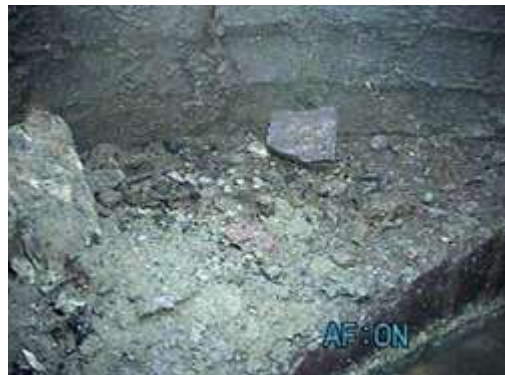
Defect 4

bench debris

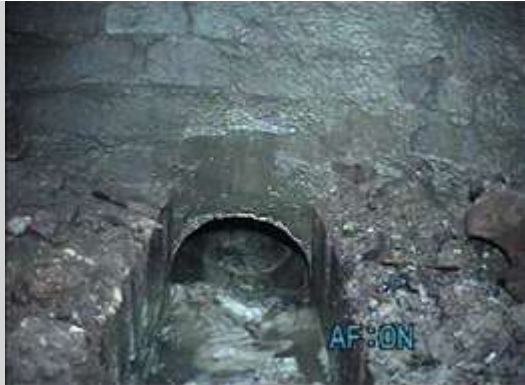
12 O'Clock Outflow

Barrel infiltration evidence

Pipe Height: **7.2** (in.) Rod and Bar (Angled)  
Pipe Material: **Clay** ☐ Pipe Lined  
Invert Depth: **8.72** (ft.) Flow Characteristics: **Slow**  
Deposits: ☒ None ☐ Mud ☐ Sludge ☐ Debris ☐ Grease  
Silt Depth: **0** (in.) Deposits Extent:  
Infiltration: **Evidence** Pipe Seal Cond: **Unknown**

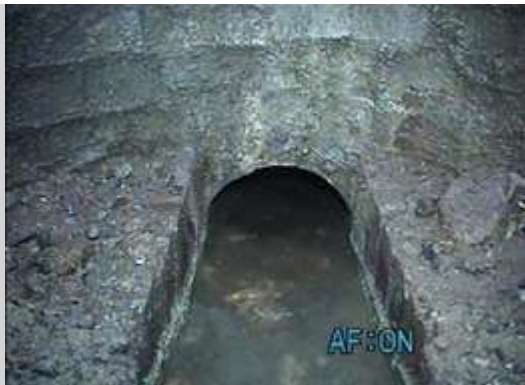
6 O'Clock Inflow

Pipe Height: **8.4** (in.) Rod and Bar (Angled)  
Pipe Material: **Clay** ☐ Pipe Lined  
Invert Depth: **8.34** (ft.) Flow Characteristics: **Slow**  
Deposits: ☒ None ☐ Mud ☐ Sludge ☐ Debris ☐ Grease  
Silt Depth: **0** (in.) Deposits Extent:  
Infiltration: **Evidence** Pipe Seal Cond: **Unknown**
